Manhole Inspection Summary

Manhole # S55I__001MH

Insp Date: **5/29/08 1:17 PM**

Location Address: **518 s highland ave**

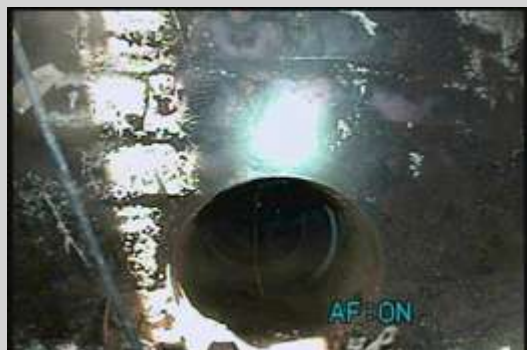
12 O'Clock Outflow

8 in. Circular Gravity Sewer
Pipe Out @ 12 O'Clock

Infiltration: **None** Pipe Seal Cond: **Unknown**
